# Health Hazards, Safety Risks and Security Threats Posed by Olusosun Dumpsite on Olusosun Community at Ojota, Lagos, Nigeria

Alani Rose, Abdulfatai Mustapha, Ogbe Rachael, Akinade Bayo. Health Hazards, Safety Risks and Security Threats Posed by Olusosun Dumpsite on Olusosun Community at Ojota, Lagos, Nigeria. *American Journal of Life Sciences*. Special Issue: Environmental Toxicology. Vol. 5, No. 3-1, 2017, pp. 43-51. doi: 10.11648/j.ajls.s.2017050301.17

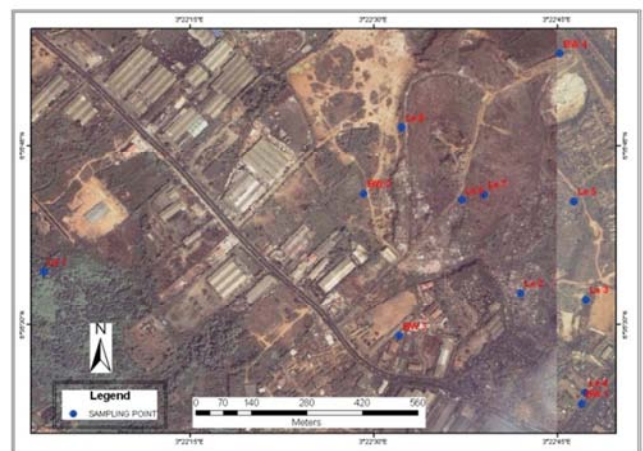
*Fig. 1. Satellite view of the sample site showing sample points.*

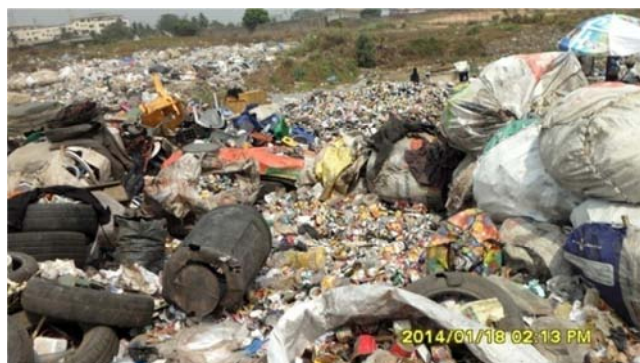
**Fig. 4.** Heaps of comingled waste on Olusosun.

Olusosun dumpsite harbors comingled wastes which include industrial waste, medical waste (as a result of need for medical care), chemical waste agricultural wastes, E-wastes, domestic and other municipal solid wastes. The Love Canal harbored various chemical wastes, including pesticides and dioxin.

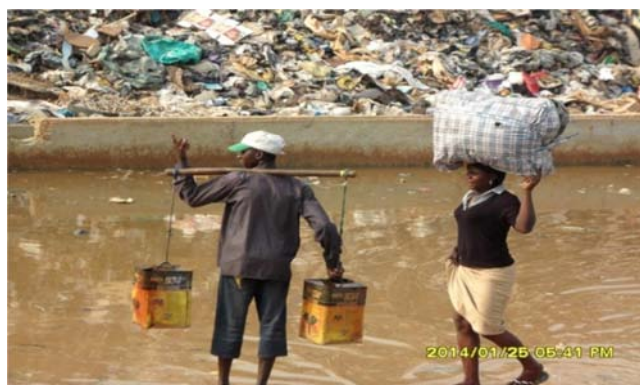
**Fig. 5.** Olusosun community members passing the percolated leachate barefooted.
